MARINE ELECTRICAL INSPECTION REPORT

Cockpit Instrument Power — Investigation & Findings

██████████	██████████
██████████	██████████
██████████	██████████
Prepared By	Jeremyn Horsley - Sure Shot Marine (510) 930-1239 www.sureshotmarine.com
Scope	Targeted investigation of intermittent power loss to cockpit sailing instruments. Battery voltages measured. Safety systems, shore power, and battery load/capacity testing were NOT within scope of this inspection.

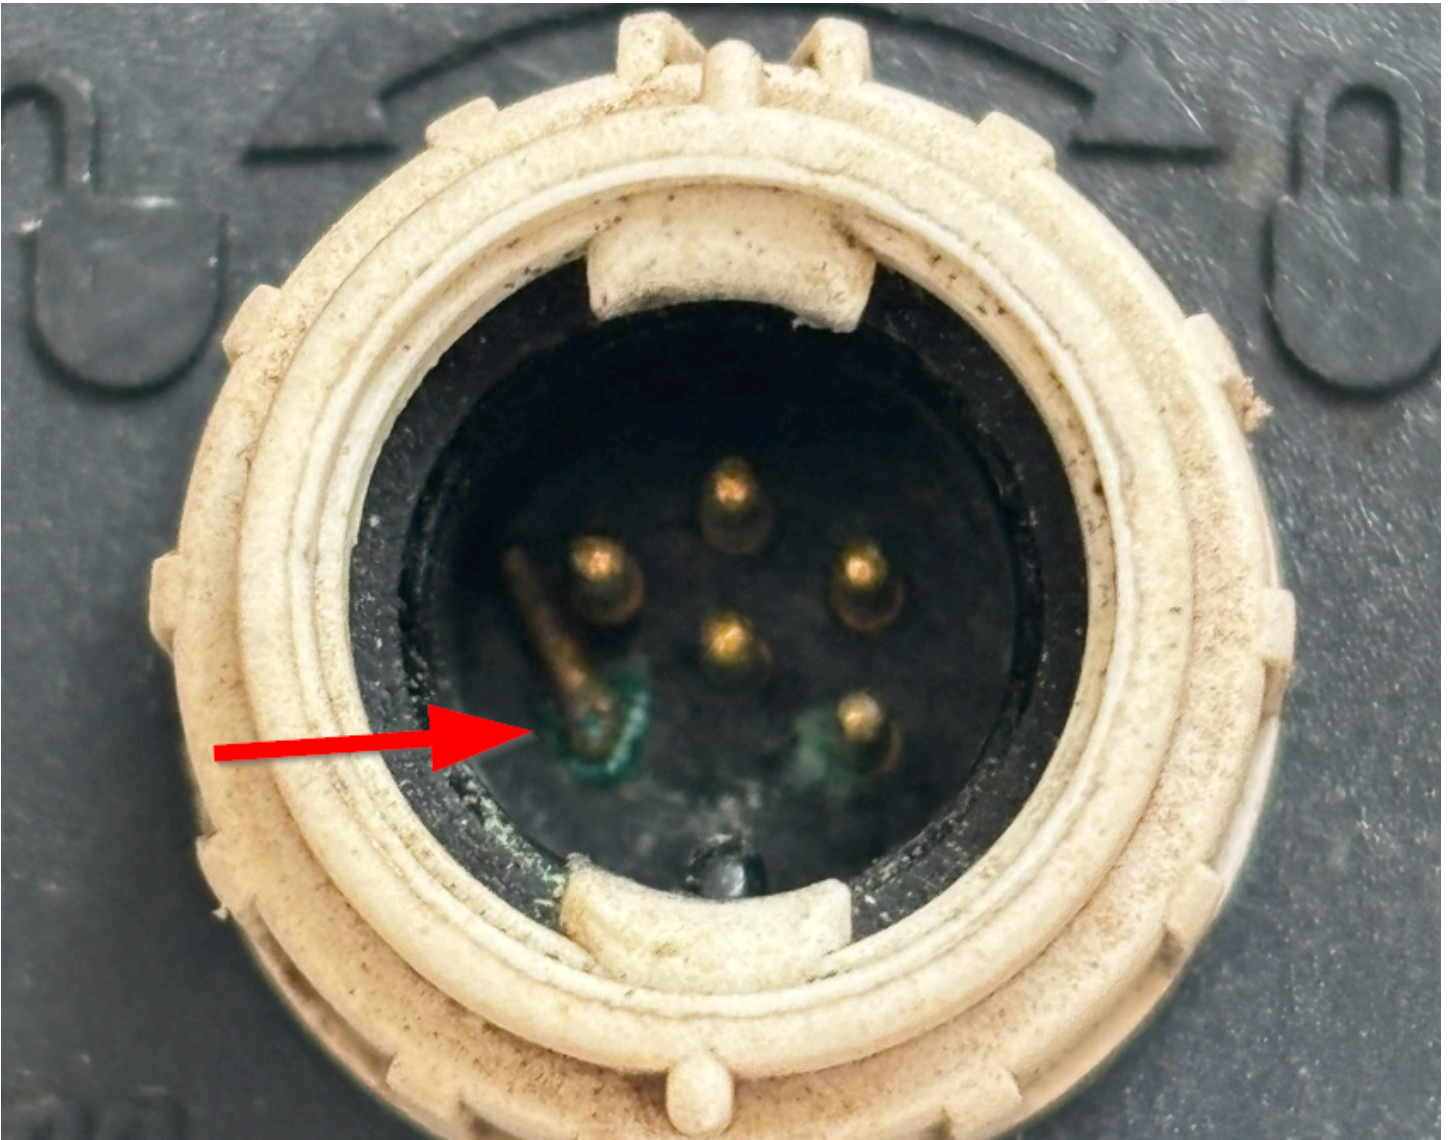
#	Location	Finding	Severity	Recommendation
1	Starboard cockpit — ST70 SeaTalk connector	Bent/broken Pin 1 (DC+) in SeaTalk connector. Melted insulation on the spur cable at Pin 1 indicates prior heat damage from a high-resistance connection at this pin. Corrosion also present inside the connector (origin unknown; connector should be watertight).	CRITICAL	Replace the ST70 and spur cables

The root cause of the intermittent cockpit instrument power loss was confirmed to be a bent/broken Pin 1 (DC positive) in the SeaTalk connector on the starboard cockpit ST70 display. Pin 1 carries the 12V supply that powers all instruments on the SeaTalk spur; a compromised pin at this point would cause intermittent or total loss of power to the connected instruments.

Physical evidence of heat damage was found on the SeaTalk spur cable at the Pin 1 connector — the insulation showed signs of melting. This indicates the pin had been creating a high-resistance connection for some time, generating heat under load before ultimately failing. A high-resistance DC positive connection causes exactly the kind of intermittent behavior described by the owner: instruments that flicker, drop out, or fail to start under varying conditions.

The presence of corrosion inside the connector is a secondary finding. The origin of the corrosion is unknown, as the SeaTalk connector is rated as watertight in normal conditions. Possible causes include: a prior improperly seated connector allowing water ingress over time, condensation accumulation, or contamination introduced during a previous service. The corrosion compounds the contact resistance issue but the bent pin is the primary failure mechanism.

ST70 connection bent pin.

- Replace the starboard ST70 and spur cables.
- Inspect the repaired butt connector on the house battery VHF power feed; schedule full replacement of the corroding wiring run at the earliest opportunity. [FINDING #3]

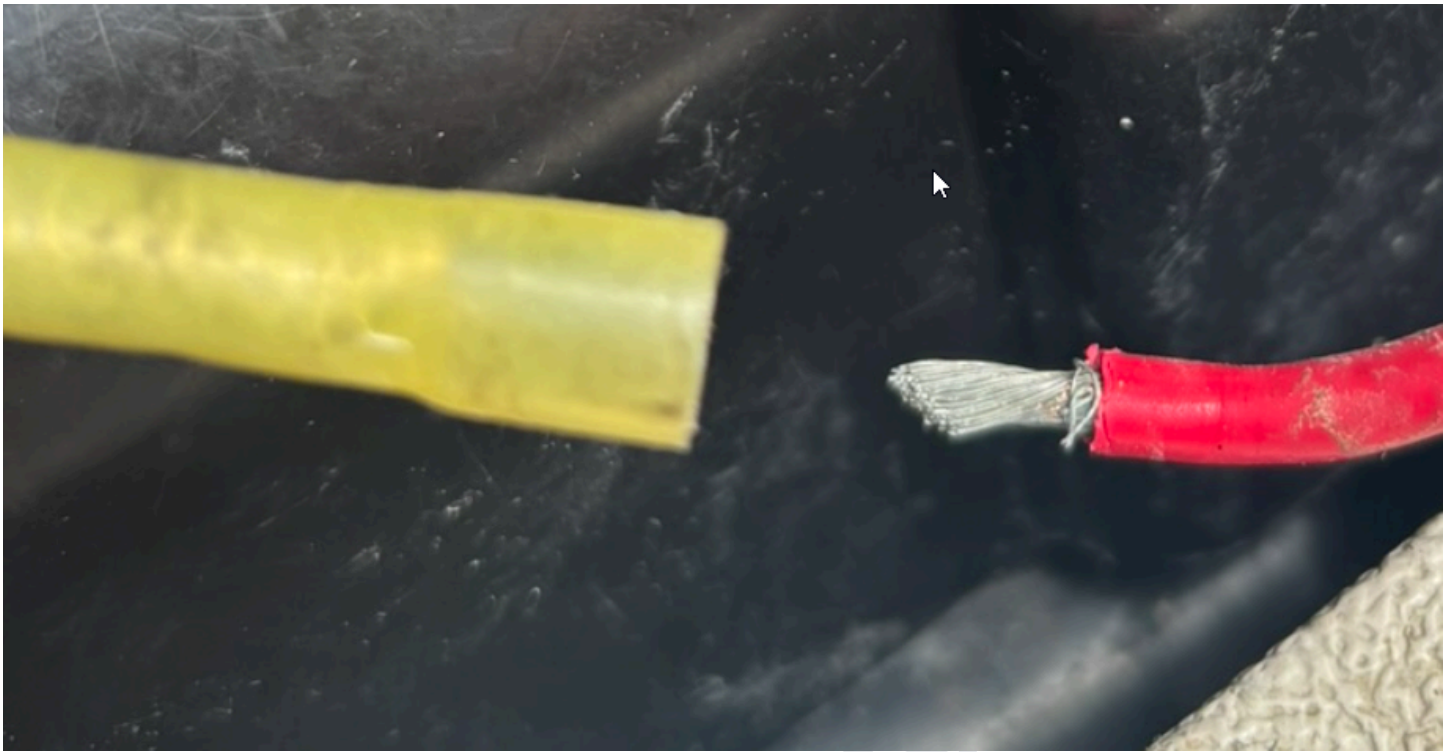
- House Battery — West Marine, MCA 705A, RC 90 min; located in the starboard cockpit locker. Labeled HOUSE. Dated November 2025. An inline fuse holder on the positive feed cable was coming loose; electrical tape was applied as a temporary fix. A yellow butt connector on the VHF power feed was found un-crimped (causing intermittent VHF power loss). The butt connector was crimped as a temporary repair to allow the vessel to get underway. The wiring at this connection is corroding and should be replaced.
- Starting Battery — West Marine, MCA 1000A, RC 130 min; located in the starboard cockpit locker. Dated March 2026.

Uncrimped butt connector - corrosion in wire.

2	Port cockpit — ST70	ST70 would not power on. Moisture observed behind the screen, indicating water ingress. Root cause not determined during this inspection.	HIGH	Further investigation required. Attempt to power the unit via a known-good SeaTalk spur. If unresponsive, the instrument likely requires replacement. Source of moisture ingress should be identified and sealed.
3	House battery — VHF power feed butt connector	Yellow butt connector on VHF radio power feed was un-crimped, causing intermittent VHF power loss (confirmed audibly during inspection). Inline fuse holder also loose. Wiring at this connection is corroding. Butt connector was crimped as a temporary field repair.	HIGH	Temporary repair in place. Remove and replace the butt connector with a proper tinned marine-grade crimp splice or terminal block connection. Replace corroding wiring back to its source. Properly secure the inline fuse holder or replace it.

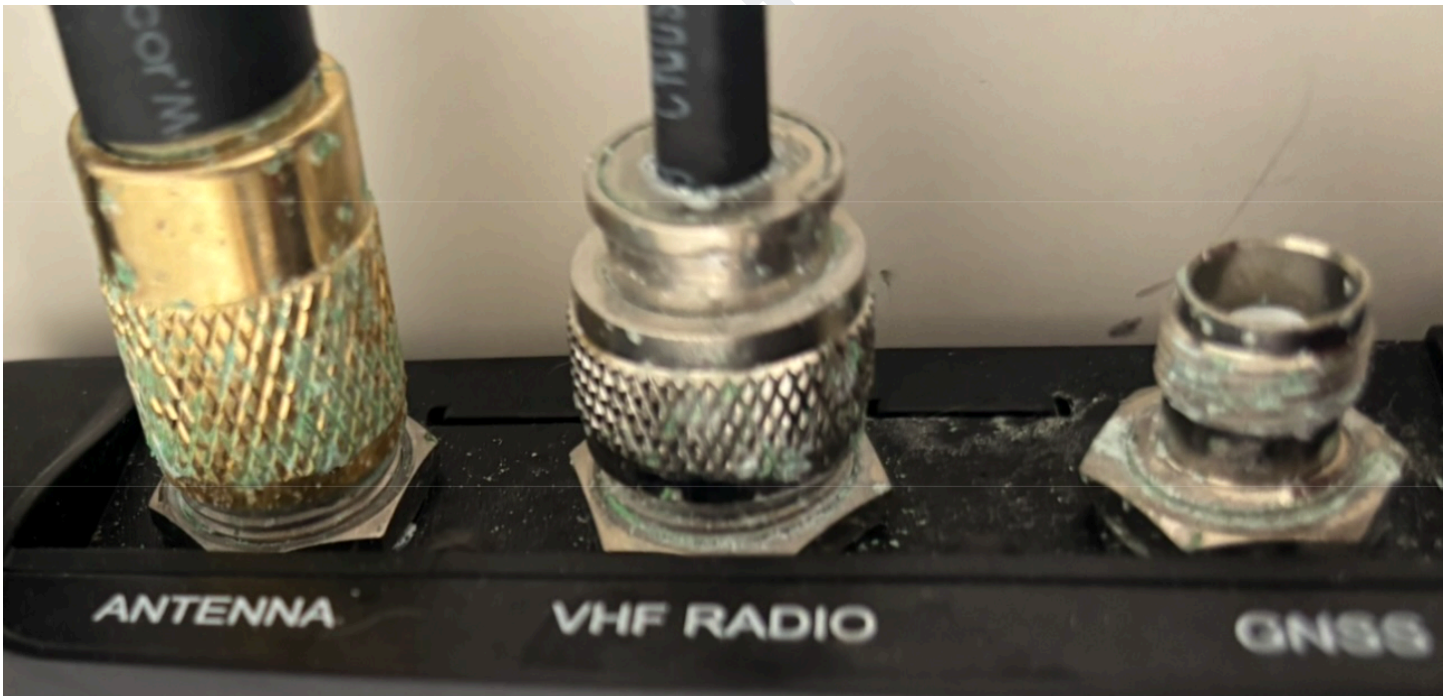
- Located on the forward berth starboard bulkhead, just below the sensor network. All three RF connectors (Antenna, VHF Radio, GNSS) show significant green corrosion on the connector bodies.

AIS connectors corroded.

4	em-trak AIS — RF connectors	All three RF connectors (Antenna, VHF Radio, GNSS) show heavy green corrosion on the connector bodies and mating threads.	HIGH	Remove connectors, clean with electrical contact cleaner, and apply corrosion inhibitor. Inspect coax cables for moisture ingress. Replace connectors if pitting is severe.
5	Port cockpit — ST60+	Instrument not verified due to temporary SeaTalk spur cable not reaching the port side during this inspection.	MODERATE	Return visit required with appropriate cable length to verify instrument powers on and reads correctly.
6	Starboard cockpit — ST60+ speed display	ST60+ powered on when connected via temporary spur, but did not display speed data.	MODERATE	Investigate speed transducer network path. Verify the speed transducer converter in the forward berth is correctly connected and functioning. Check SeaTalk data bus for speed data.
7	Engine space — legacy distribution block	Observed during inspection: distribution block wiring is heavily corroded and disorganized. Not the focus of this inspection but presents a reliability and safety concern.	MODERATE	A dedicated audit of the engine space distribution block is recommended as a separate work item.
